ILLINOIS ENVIRONMENTAL PROTECTION AGENCY

Re: Illinois State Fairgrounds - Horse Barn Manure Handling
Springfield Township/Sangamon County
Facility ID (167CH)

COMPLAINT RECEIPT & REPORT FORM

RESULTS OF INVESTIGATION

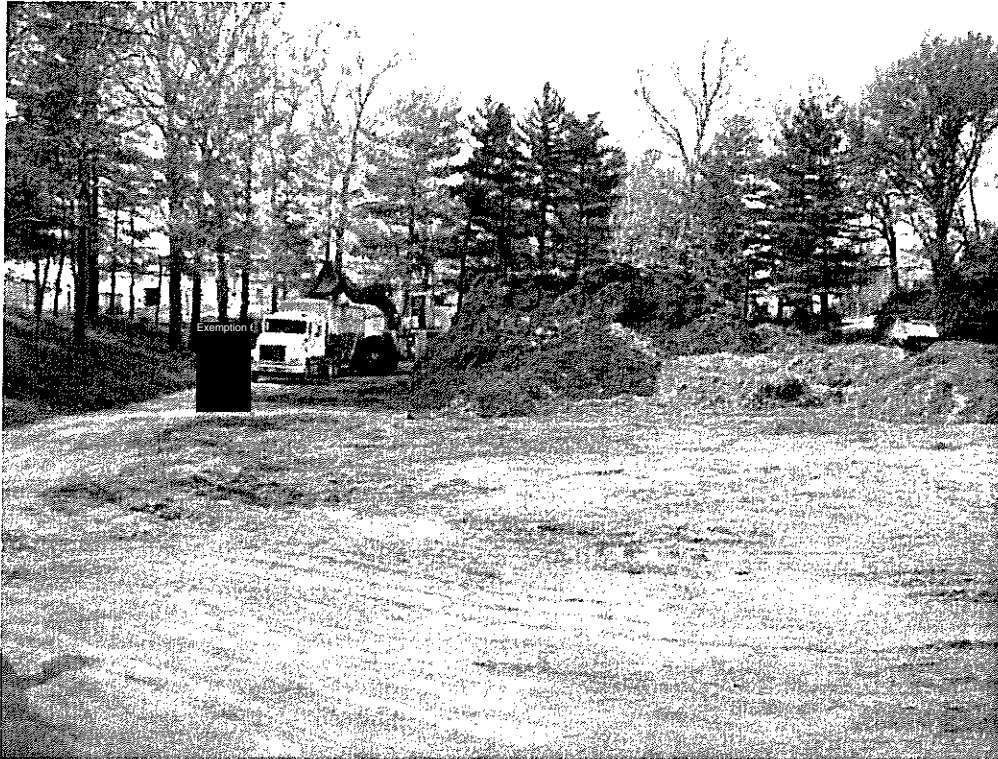
Date: 4/3/12
Time: 1:38 p.m.
Direction: West
Photo by: David Ginder
Exposure #: 001
Comments:

View looking from the down gradient side of the temporary manure stack where the used horse bedding is stockpiled. I did not observe evidence of runoff from the manure stack. The manure stack is removed every three (3) days or so (once enough material has accumulated to keep the trucks hauling from the pile for a full day).

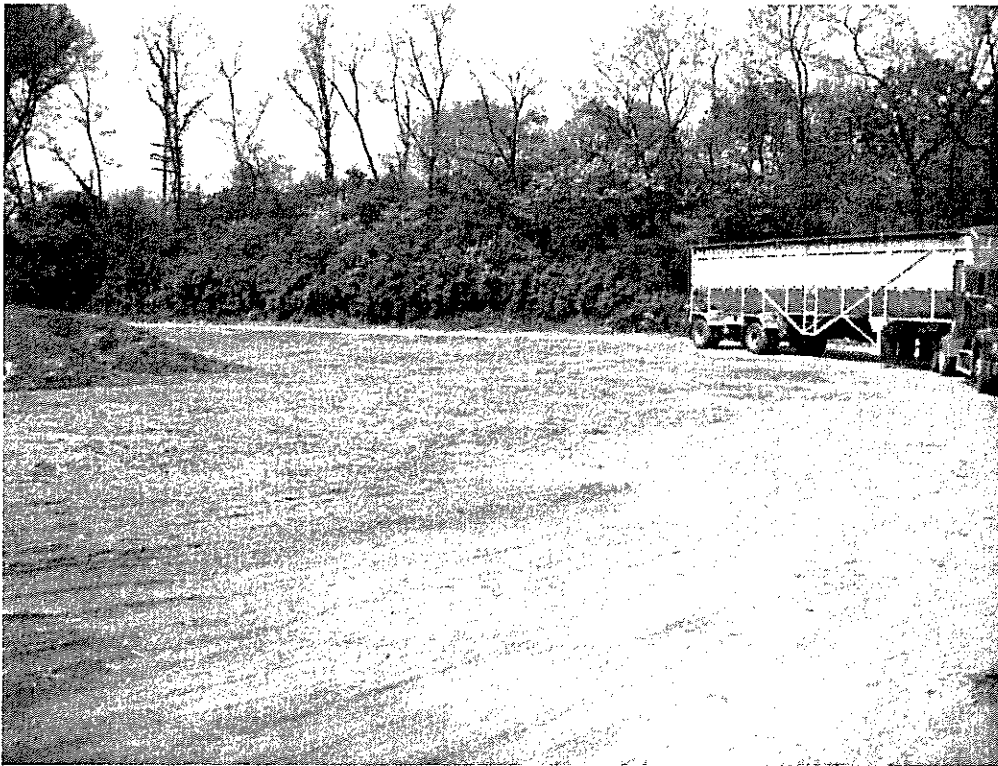
Date: 4/3/12
Time: 1:38 p.m.
Direction: Northwest
Photo by: David Ginder
Exposure #: 002
Comments:

View looking from the down gradient side of the temporary manure stack where the used horse bedding is stockpiled. I did not observe evidence of runoff from the manure stack.

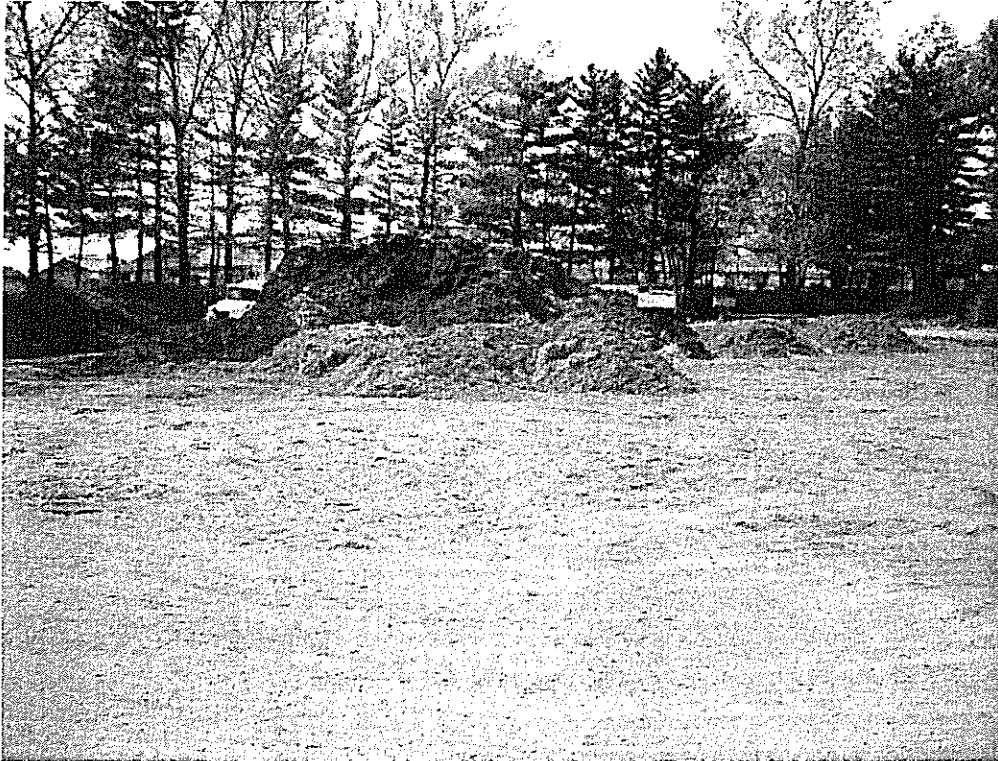
Date: 4/3/12
Time: 1:39 p.m.
Direction: West
Photo by: David
Ginder
Exposure #: 003
Comments:

View of the temporary manure stack. I observed the stack to consist mostly of bedding material having a minimal amount of manure solids.

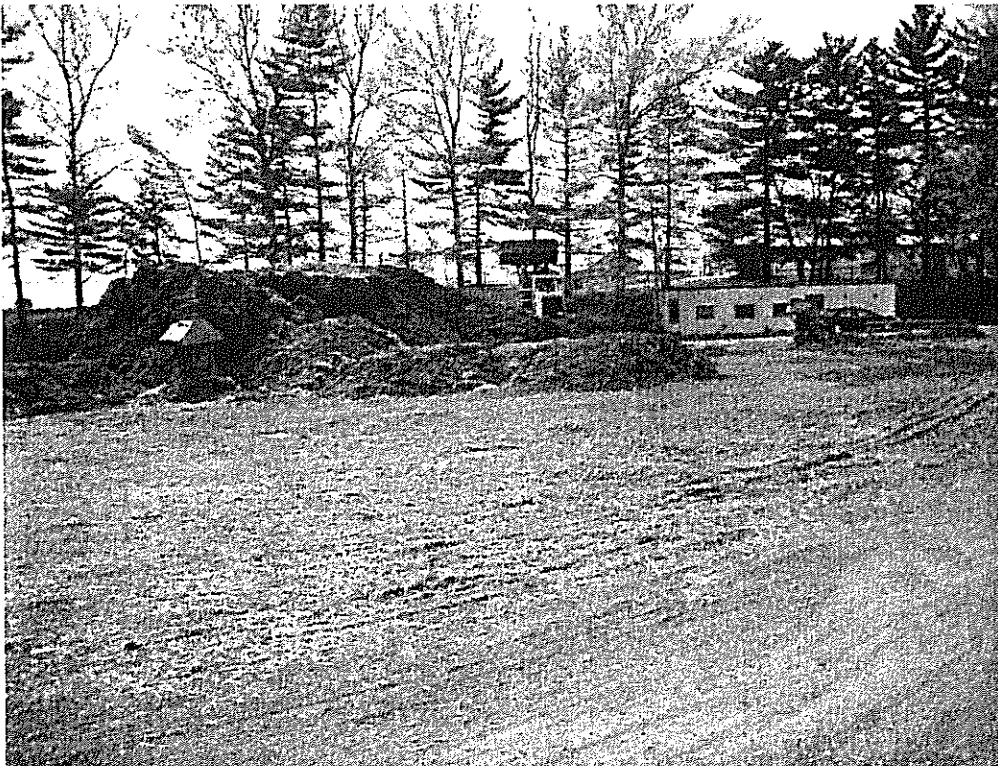
Date: 4/3/12
Time: 1:40 p.m.
Direction: Southwest
Photo by: David
Ginder
Exposure #: 007
Comments:

View of the temporary manure stack and truck loading operation.

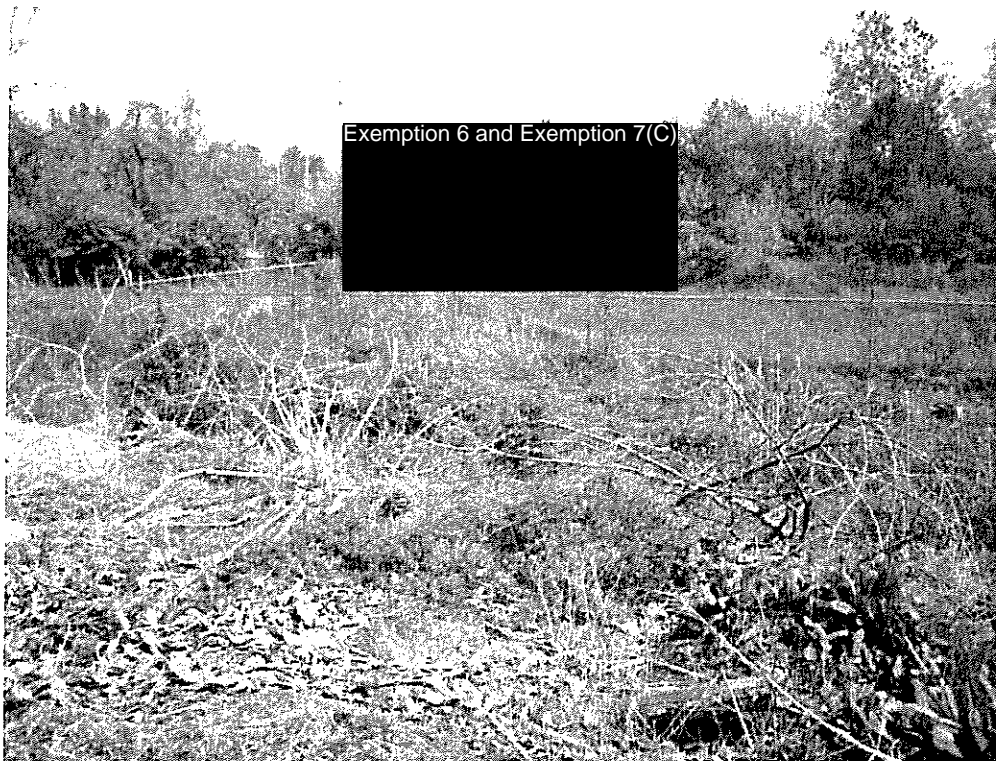
Date: 4/3/12
Time: 1:39 p.m.
Direction: Northeast
Photo by: David Ginder
Exposure #: 004
Comments:

View of the area down gradient of the temporary manure stack. The area immediately down gradient of the stack consists of a well-vegetated storm water detention basin. I did not observe evidence of manure solids in the basin or evidence of recent discharges to the basin.

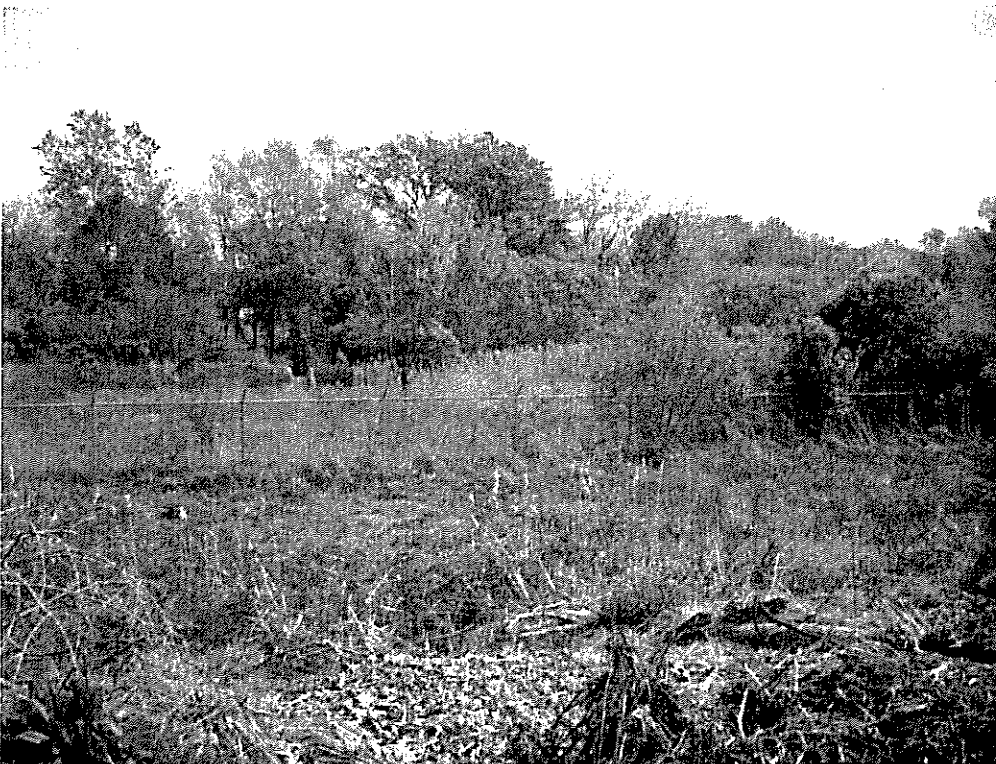
Date: 4/3/12
Time: 1:39 p.m.
Direction: East
Photo by: David Ginder
Exposure #: 005
Comments:

View of the area down gradient of the temporary manure stack location. The area immediately down gradient consists of a well-vegetated storm water detention basin. I did not observe evidence of manure solids in the basin or evidence of recent discharges to the basin.

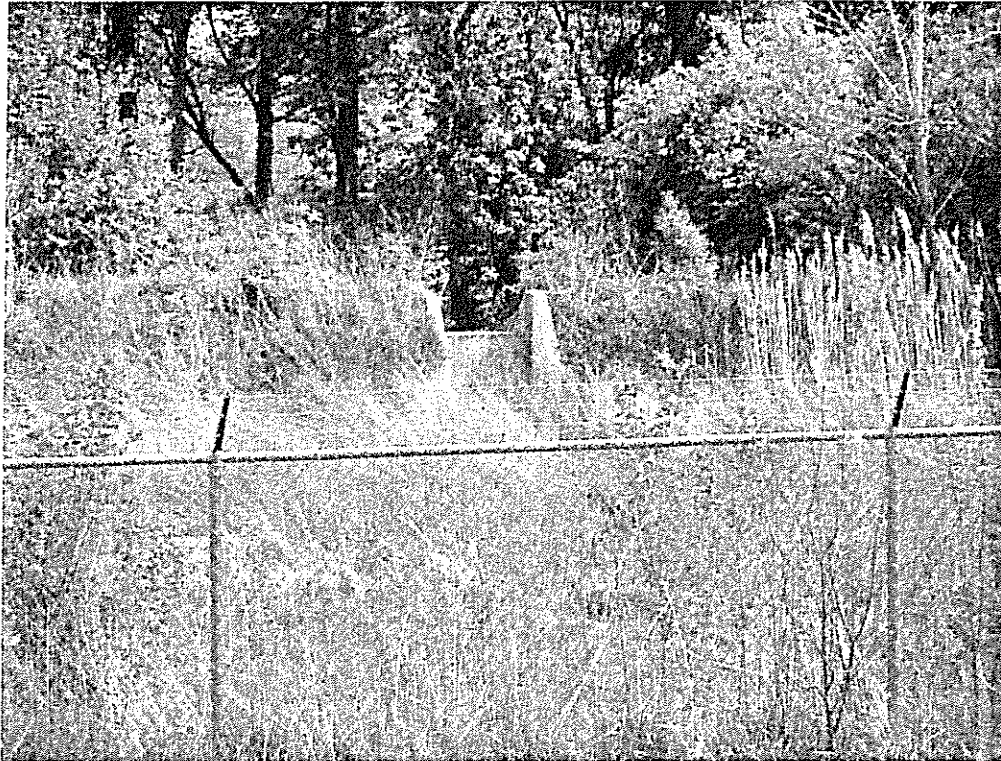
Date: 4/3/12
Time: 1:39 p.m.
Direction: East
Photo by: David Ginder
Exposure #: 006
Comments:

View of the storm water detention basin's flow control structure. Two (2) circular holes (not visible in the photograph) are located near the base of the structure. The lower hole allows the base flow from a creek (not visible) to pass through the structure and the top hole allows water in excess of the base flow generated during precipitation events to exit the structure. The concrete notch that may be observed in the photograph is the structure's emergency overflow outlet. I did not observe evidence of manure solids in the creek.
